RE: Taos Regional Landfill; Minor; Industrial Permit; SIC 4953; NPDES Compliance Evaluation Inspection; NPDES NMU001893; March 19, 2015

NPDES Compliance Inspection Report

**Compliance Evaluation Inspection
Taos Regional Landfill
March 19, 2015
NMU001893**

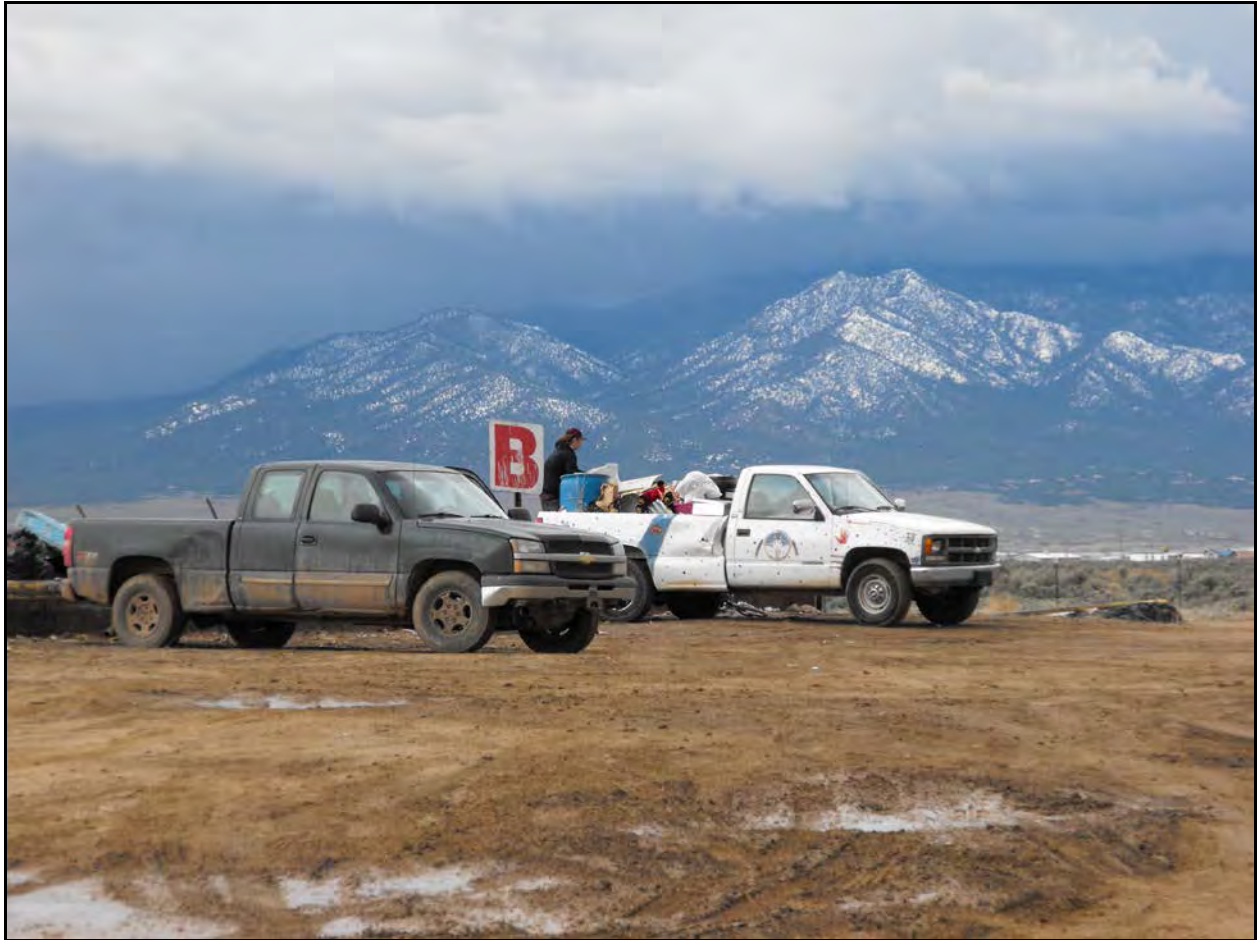
Photo # 1

Photographer: Daniel Valenta	Date: 3/19/15	Time: 1532 hours
City/County: Northwest of Taos, NM	Taos County	
Location: Taos Regional Landfill, about 4.4miles northwest of Taos, N.M., sections 34 and 35 projected, range 12 east, township 26 north, NMPM, facing east.		
Subject: Unloading area at the TRLF.

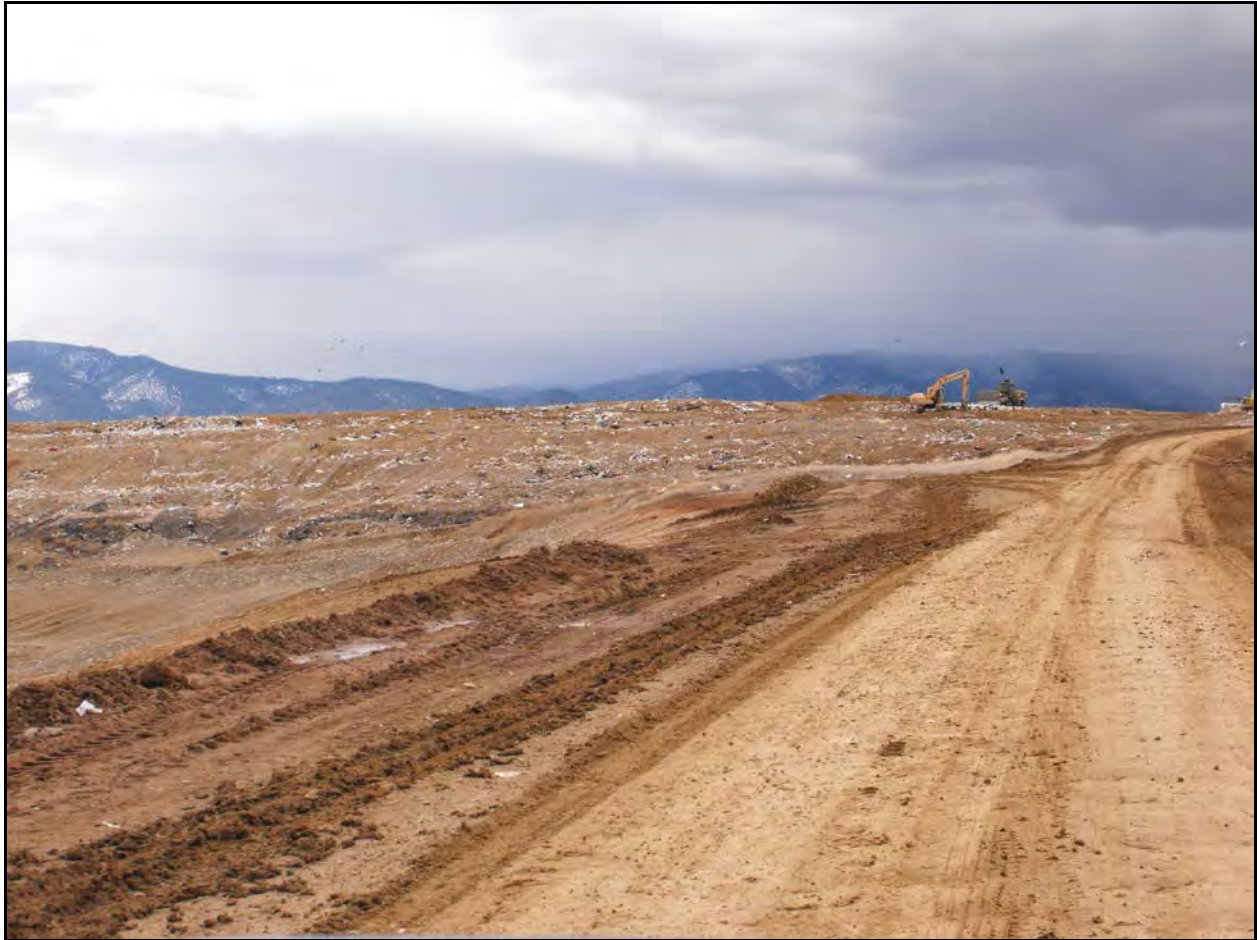
Photo # 2

Photographer: Daniel Valenta	Date: 3/19/15	Time: 1537 hours
City/County: Northwest of Taos, NM	Taos County	
Location: TRLF, about 4.4miles northwest of Taos, N.M., sections 34 and 35 projected, range 12 east, township 26 north, NMPM, facing east.		
Subject: Storage cell at the TRLF. Rainstorm approaching facility.

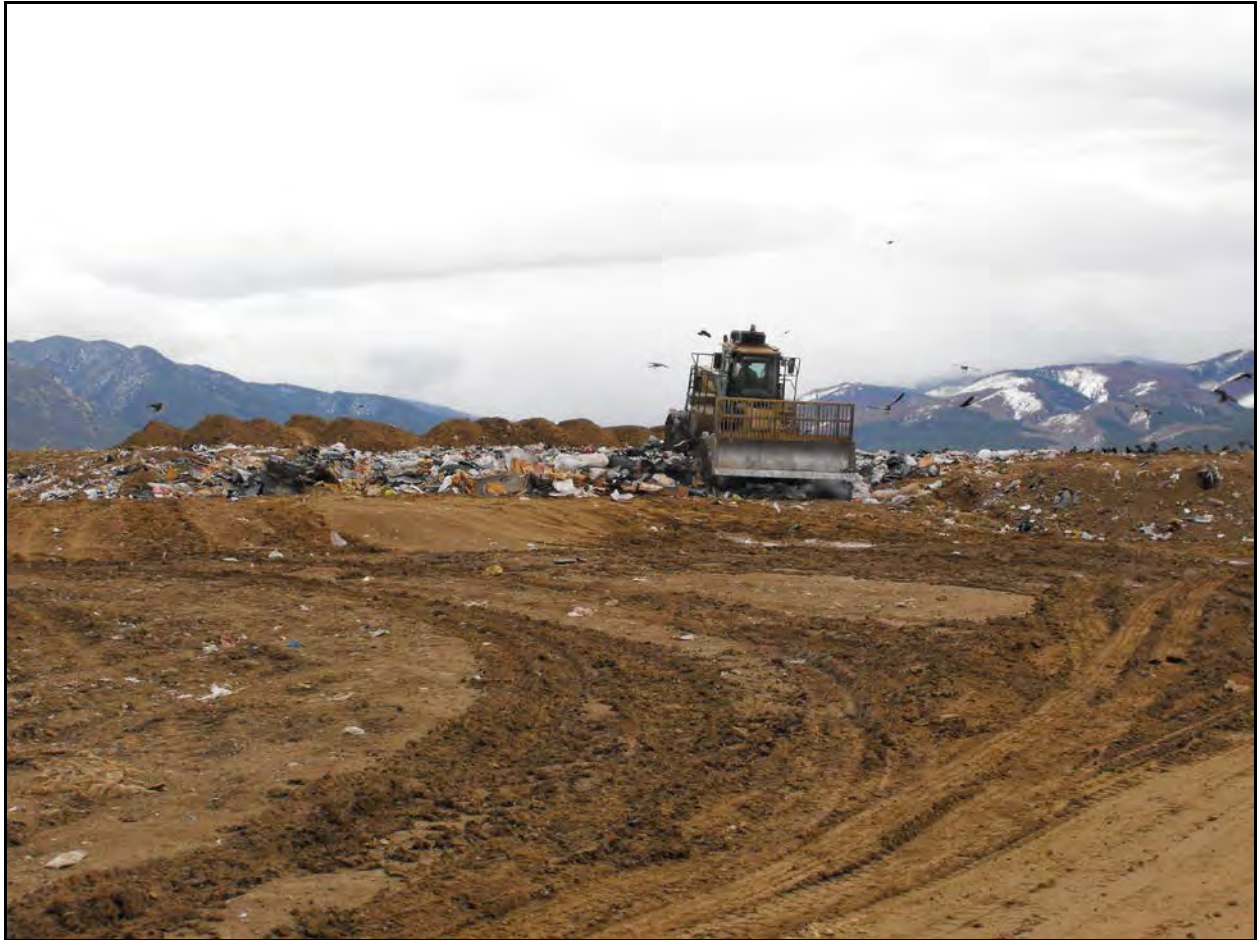
Photo # 3

Photographer: Daniel Valenta	Date: 3/19/15	Time: 1539 hours
City/County: Northwest of Taos, NM	Taos County	
Location: TRLF, about 4.4miles northwest of Taos, N.M., sections 34 and 35 projected, range 12 east, township 26 north, NMPM, facing northeast.		
Subject: Activity at the TRLF, covering dirt in background.

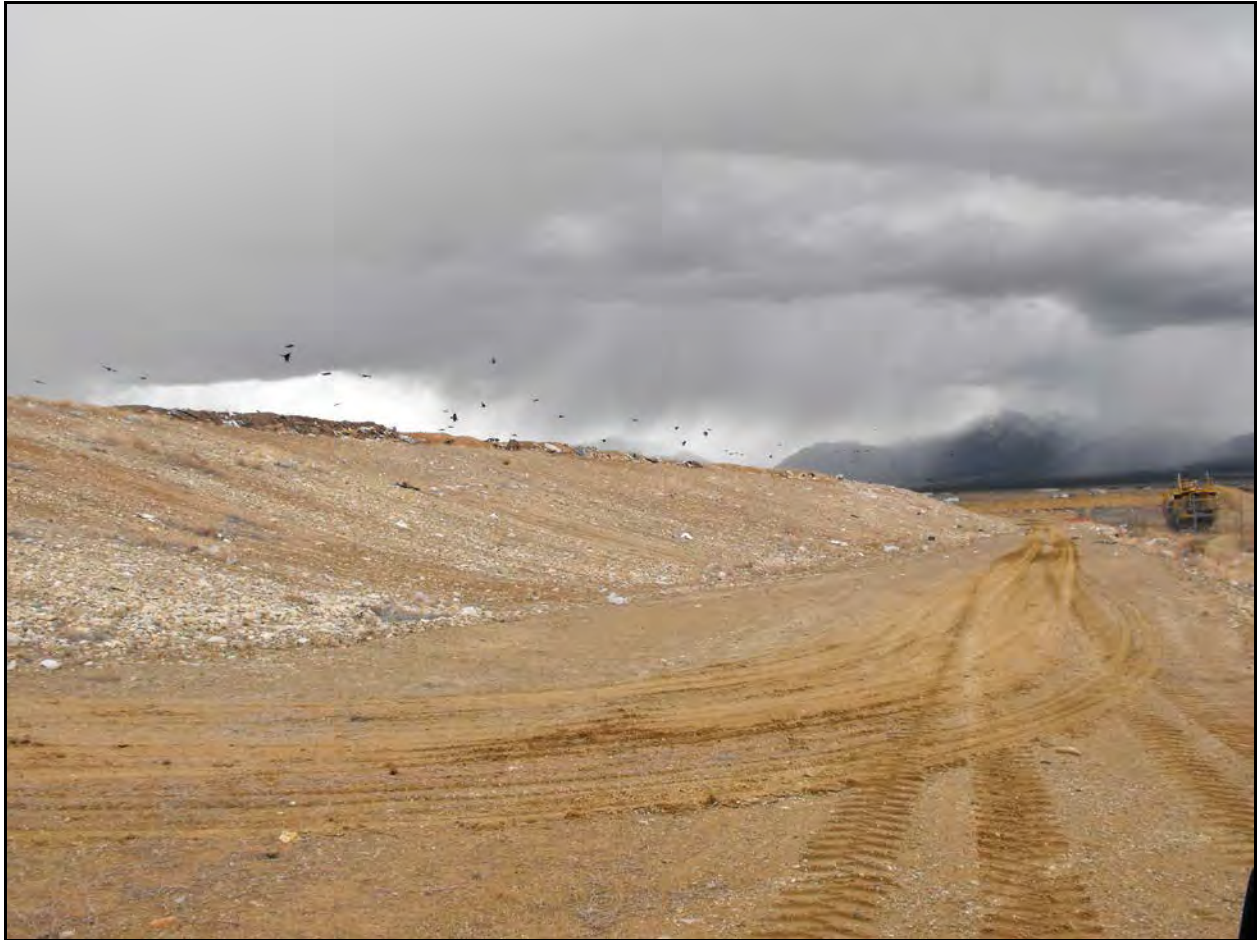
Photo # 4

Photographer: Daniel Valenta	Date: 3/19/15	Time: 1539 hours
City/County: Northwest of Taos, NM	Taos County	
Location: TRLF, about 4.4miles northwest of Taos, N.M., sections 34 and 35 projected, range 12 east, township 26 north, NMPM, facing northeast.		
Subject: Storage cell at the TRLF. Rainstorm approaches facility.
